1. AGENCY USE ONLY (Leave blank)	2. REPORT DATE 1996	3. REPORT TYPE AND DATES COVERED Final Report		
4. TITLE AND SUBTITLE The Old Hospital Complex (5EP1778) Fort Carson, Colorado		5. FUNDING NUMBERS

13. ABSTRACT (Maximum 200 words) <p>The Old Hospital Complex (5EP1778) at Fort Carson, Colorado, consists of 59 buildings. The Complex was built during World War II and is significant due to its association with the history of the United States. The complex is semi-permanent construction, constructed from the Department of the Army's Series 800 plans. This report documents the complex in accordance with Section 1(g) of the Memorandum of Agreement enacted among the Department of the Army, Headquarters Fort Carson, the Colorado State Historic Preservation Office, and the Advisory Council on Historic Preservation.</p> <p style="text-align: center;">DTIC QUALITY INSPECTED 2</p>

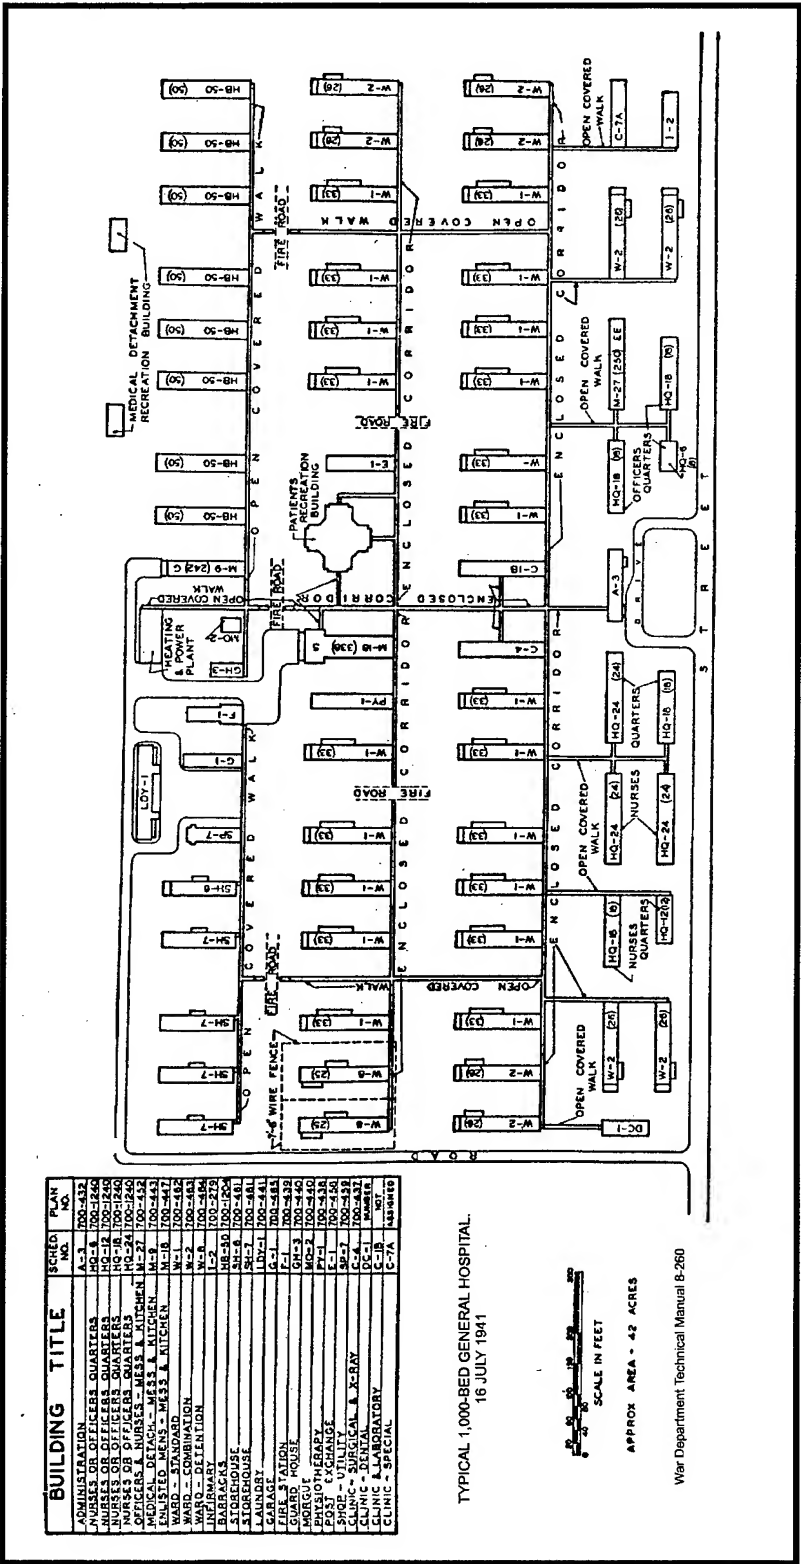
Figure II.1 Typical general hospital layout from 1941 technical manual (War Department 1941).

The general guidelines in 1941 for locating and establishing a general hospital can be found in the Technical Manual for Fixed Hospitals of the Medical Department (War Department 1941). The manual shows a typical layout for a 1,000-bed general hospital, which was to be suited to local conditions and needs (Figure II.1). In general, a 1,000-bed general hospital would have 62 buildings: 33 wards, administration, surgical, receiving and forwarding, and bath buildings, messes, and personnel buildings. The manual specifies three types of wards:

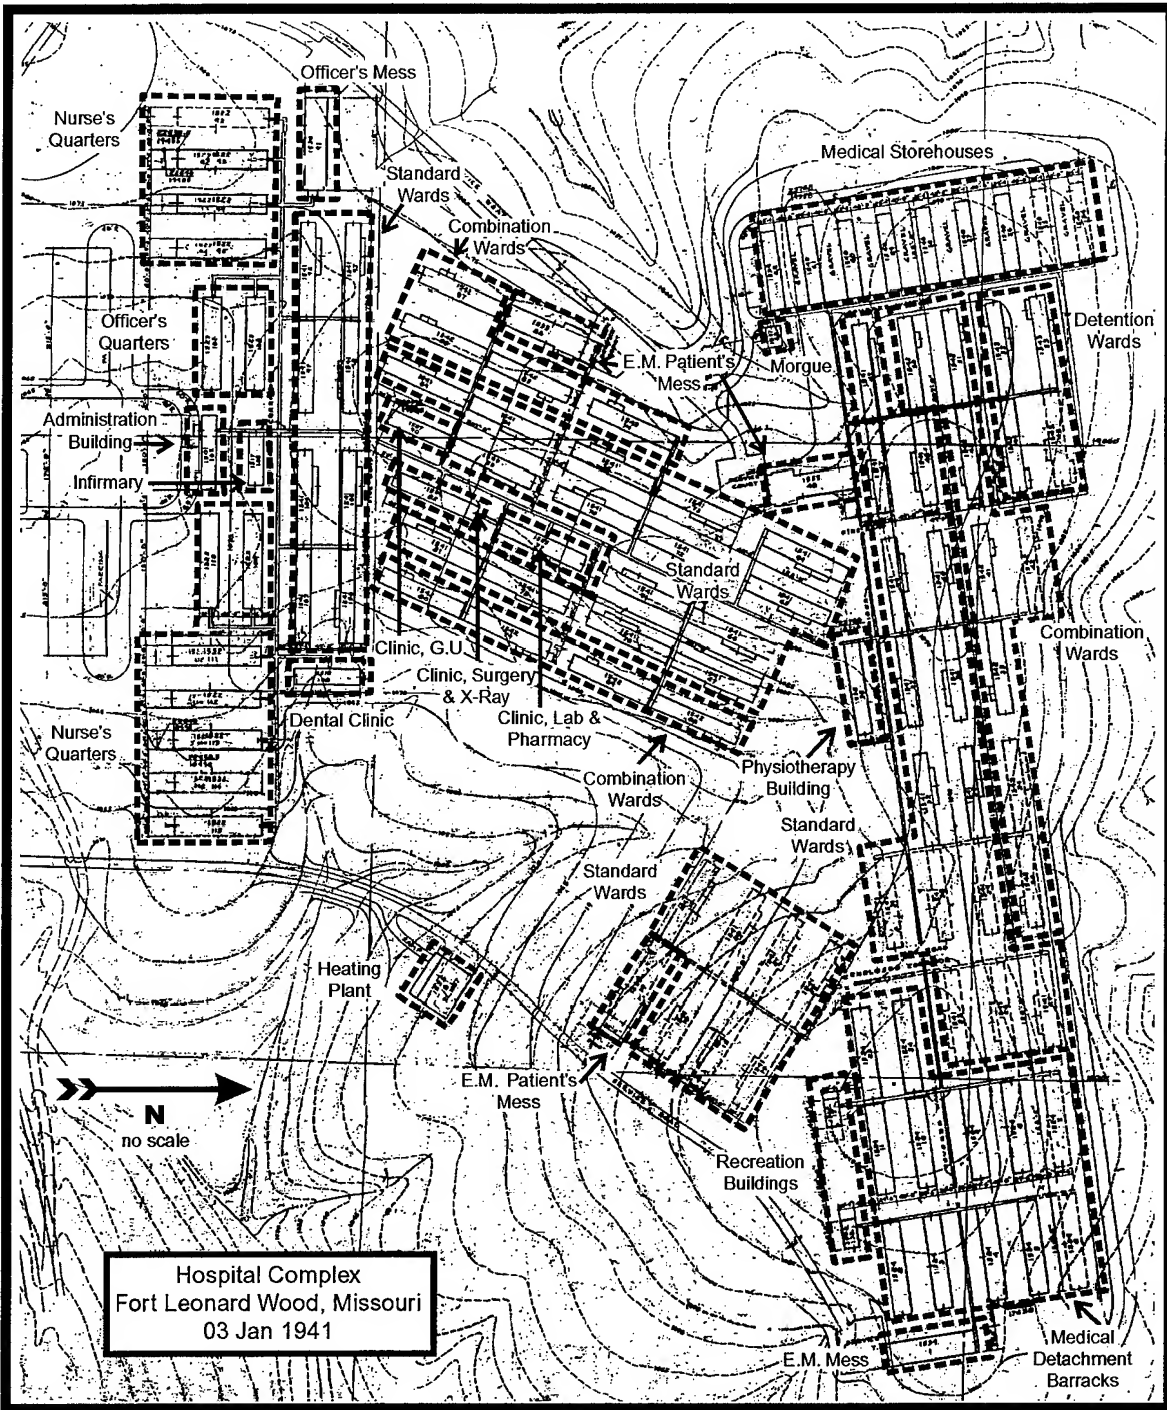
Figure II.4 Fort Leonard Wood hospital layout, January, 1941 plans.

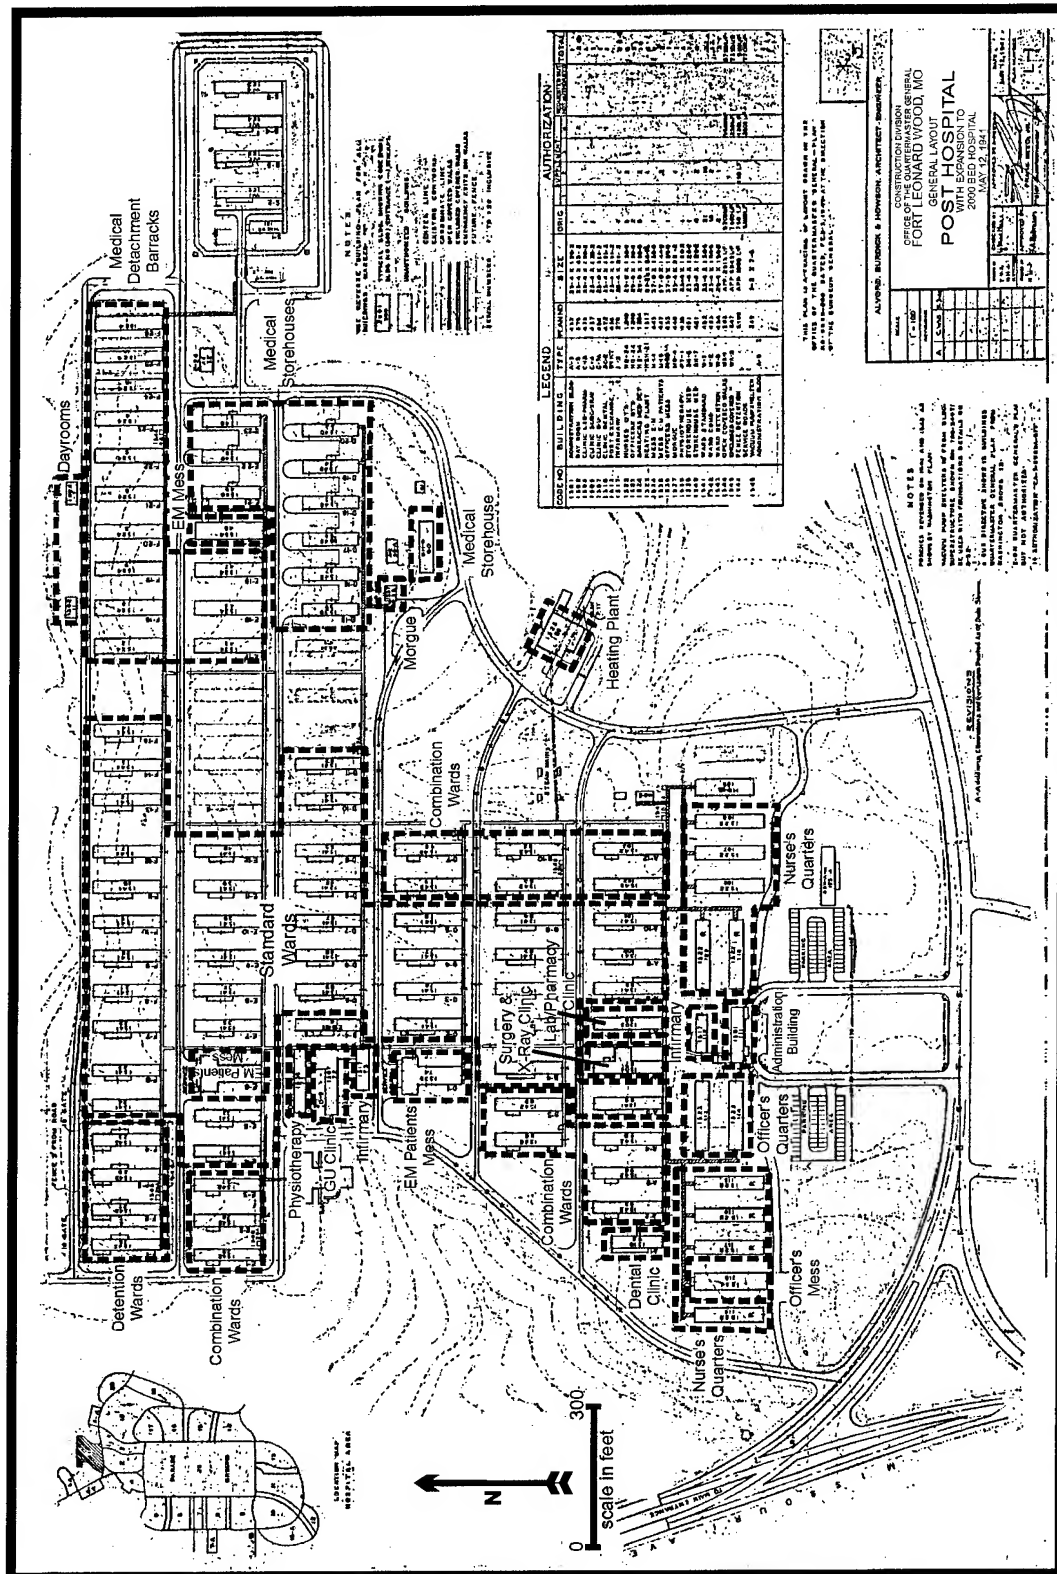
Figure 11.5 Fort Leonard Wood hospital layout, May, 1941 plans.

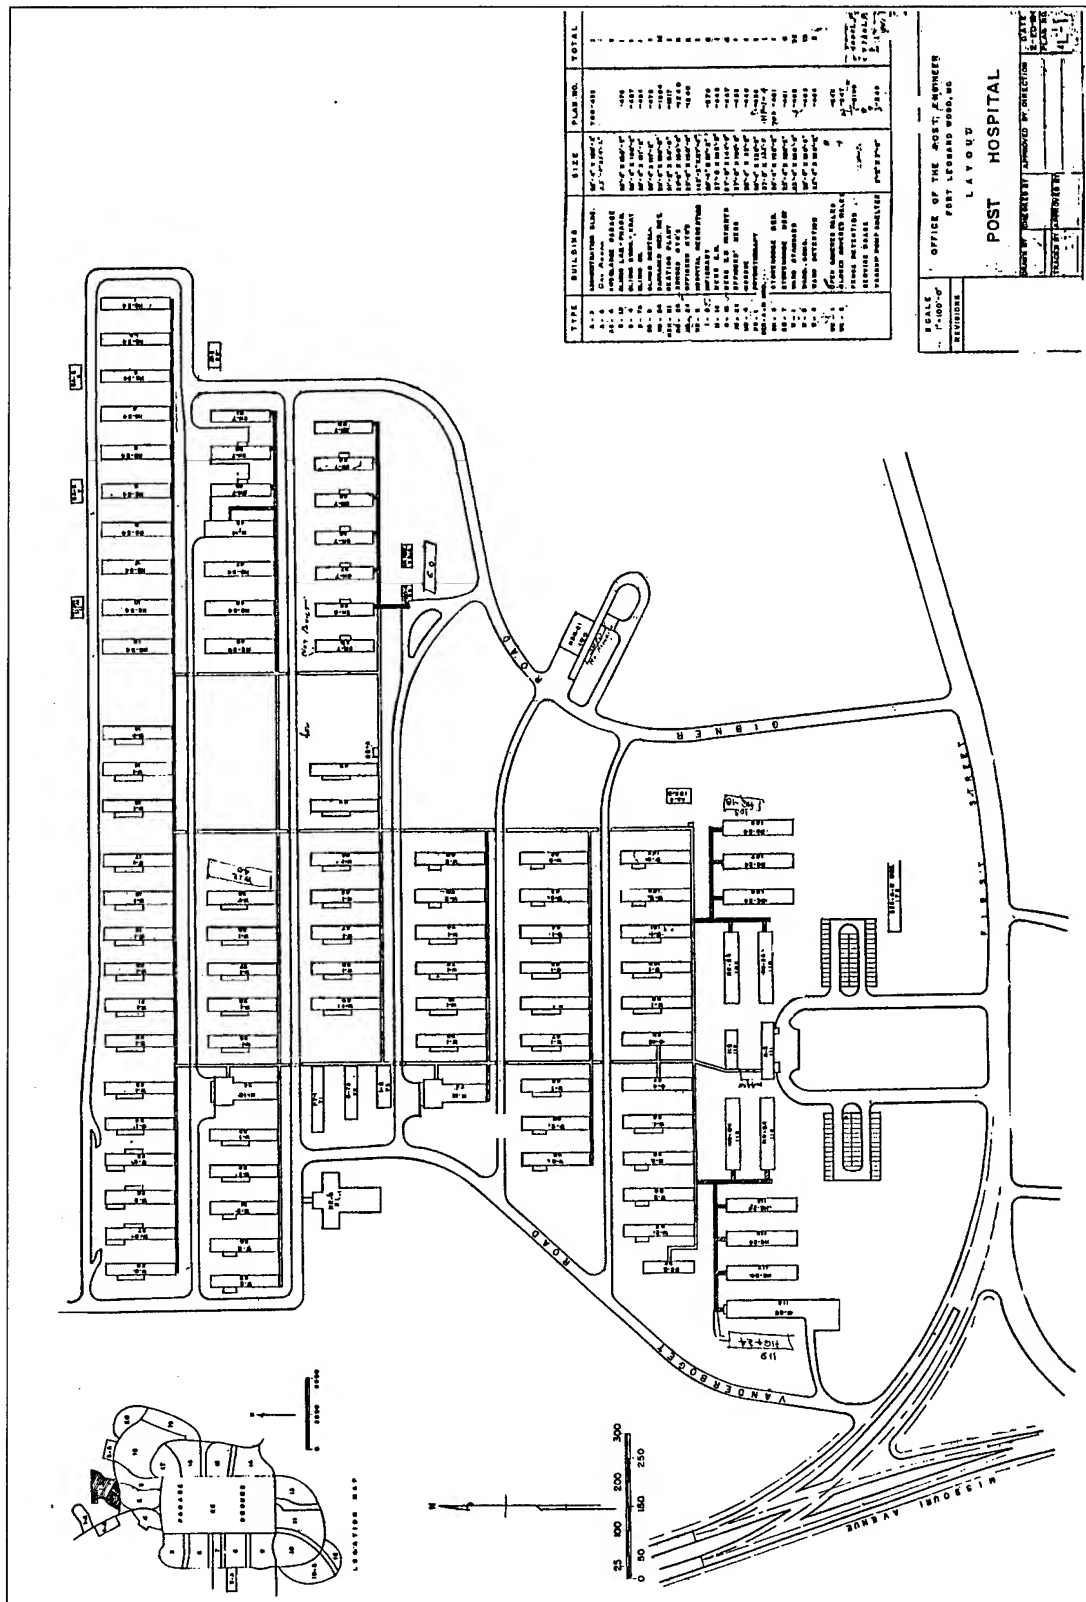
Figure II.6 Fort Leonard Wood hospital layout, February, 1943 plans.

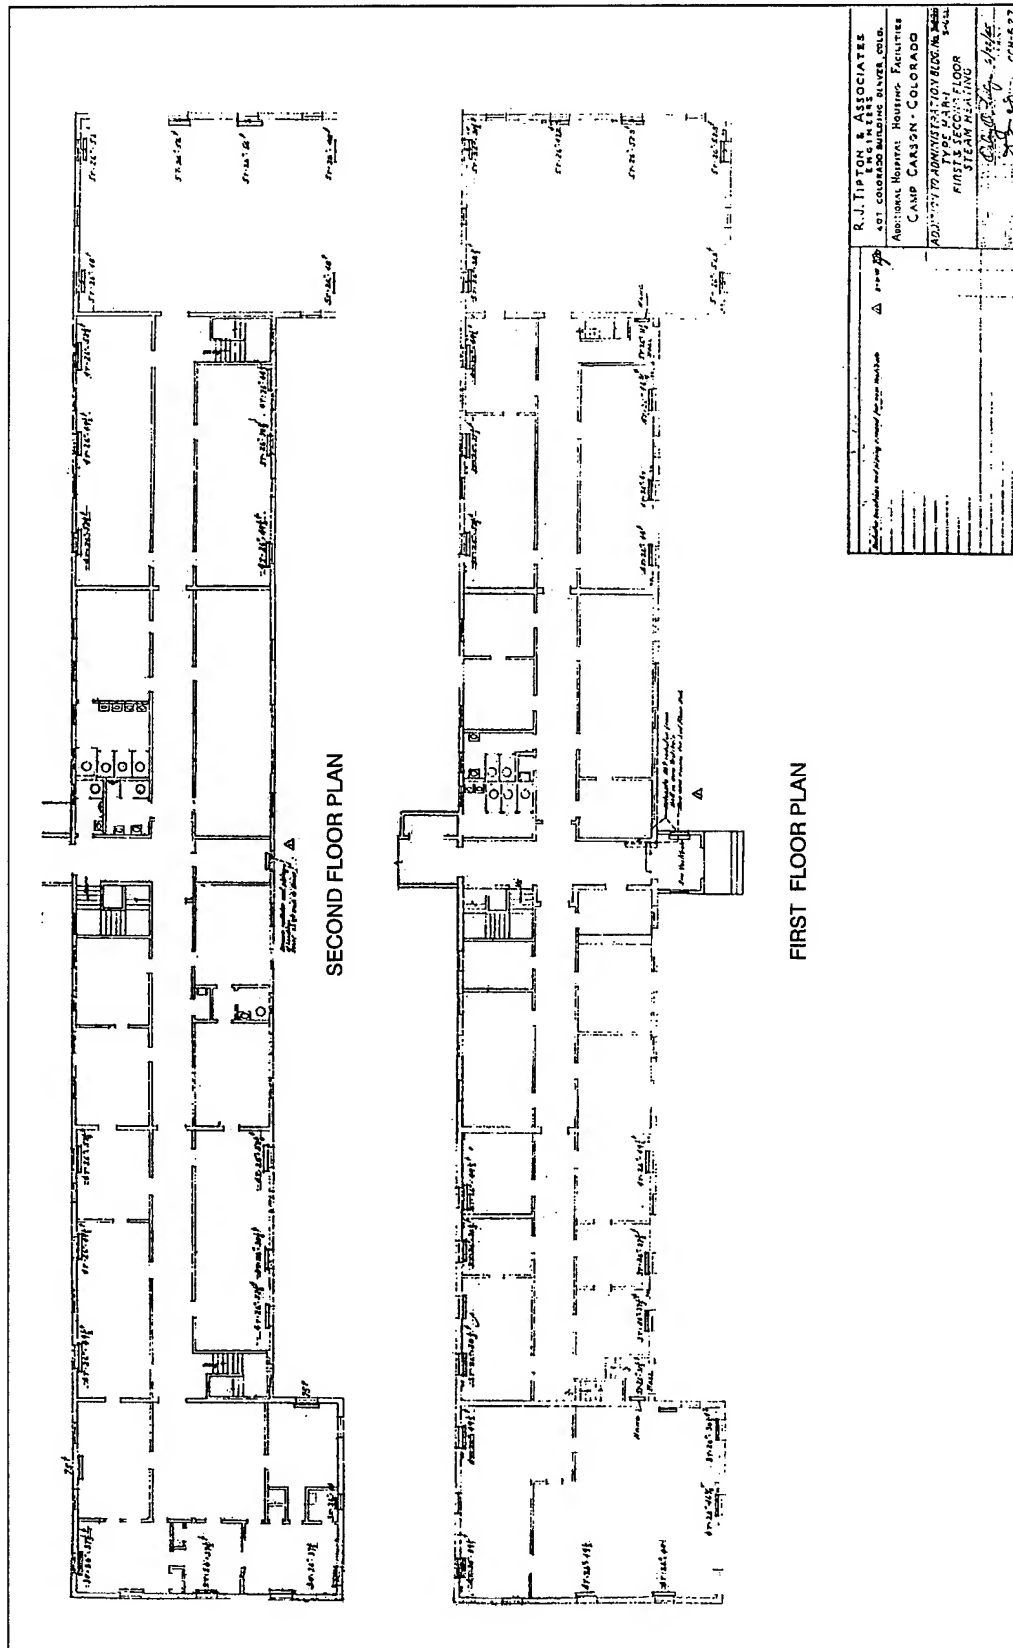
Figure V.2 5EP1778. First- and second-floor heating plans for Building S6225, Administration Building, CCH Series, Sheet 5.27.

Heat is supplied to Building S6225 through metal steam grills (radiators) fed by the OHC's central heating plant. Steam pipes run underground and in the crawlspaces of the building and corridor. Air conditioning units were installed in S6225 in 1993. Sprinkler heads from the original fire sprinkler system protrude through the dropped ceiling tiles.

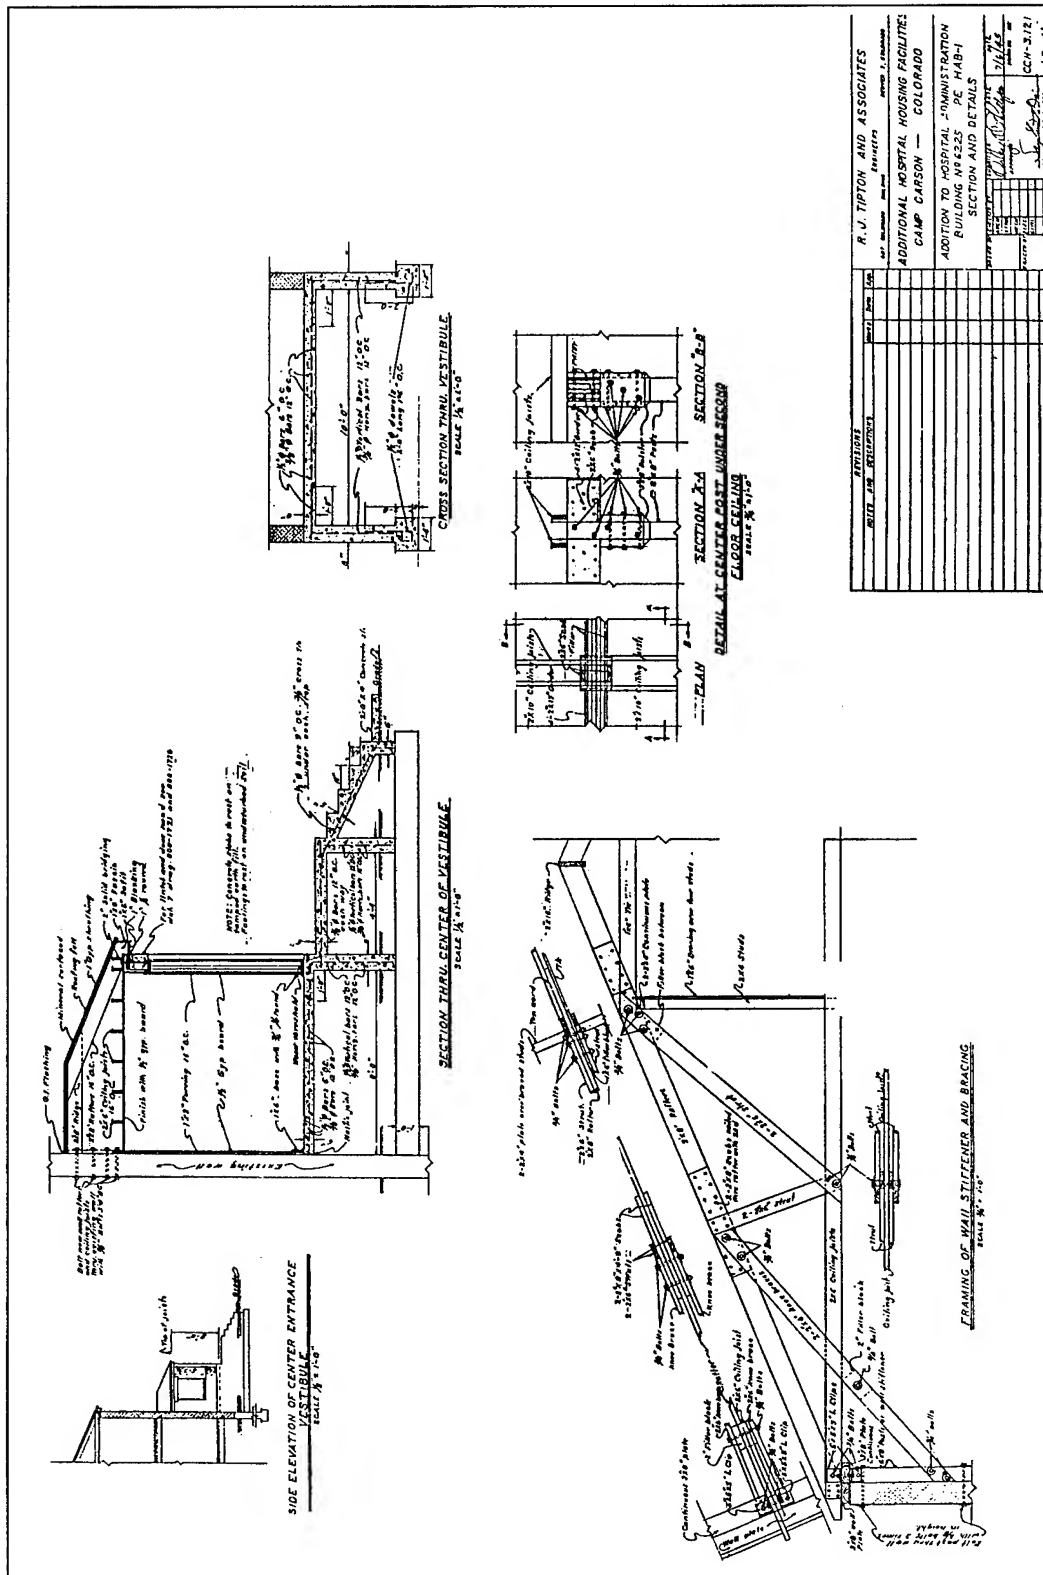
Figure V.4 5EPI778. Section and details for Building S6225, Administration Building, CCH Series, Sheet 3.121.

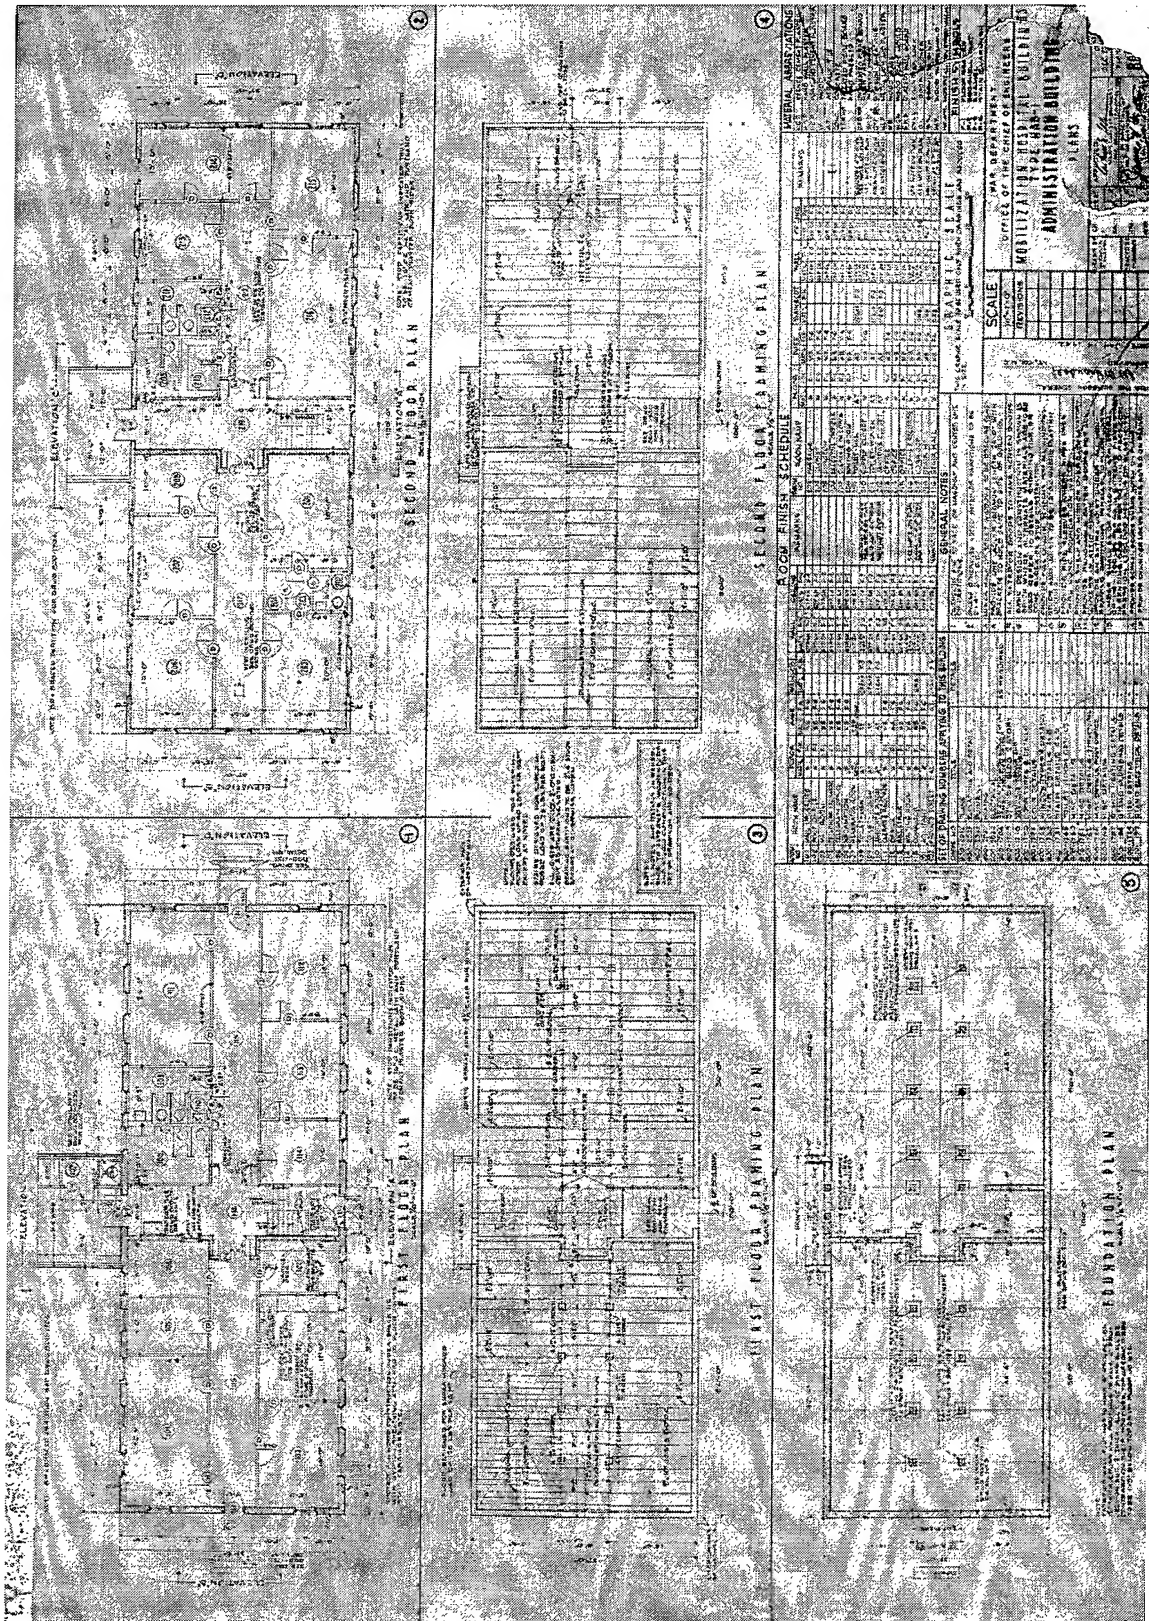
Figure V.5 5EP1778. Framing, foundation, and floor plans for Building S6225, Administration Building, 800 Series, Type HAB-1, Plan 800-2032.

The foundation consists of continuous poured-concrete foundation walls and piers. The foundation walls are one foot thick and rise from the footings to approximately 1' above grade. A small offset near the building's junction with the corridor originally held a hot potable water tank. This water was heated by the complex's central steam heating lines. It is not known if the system is still operational.

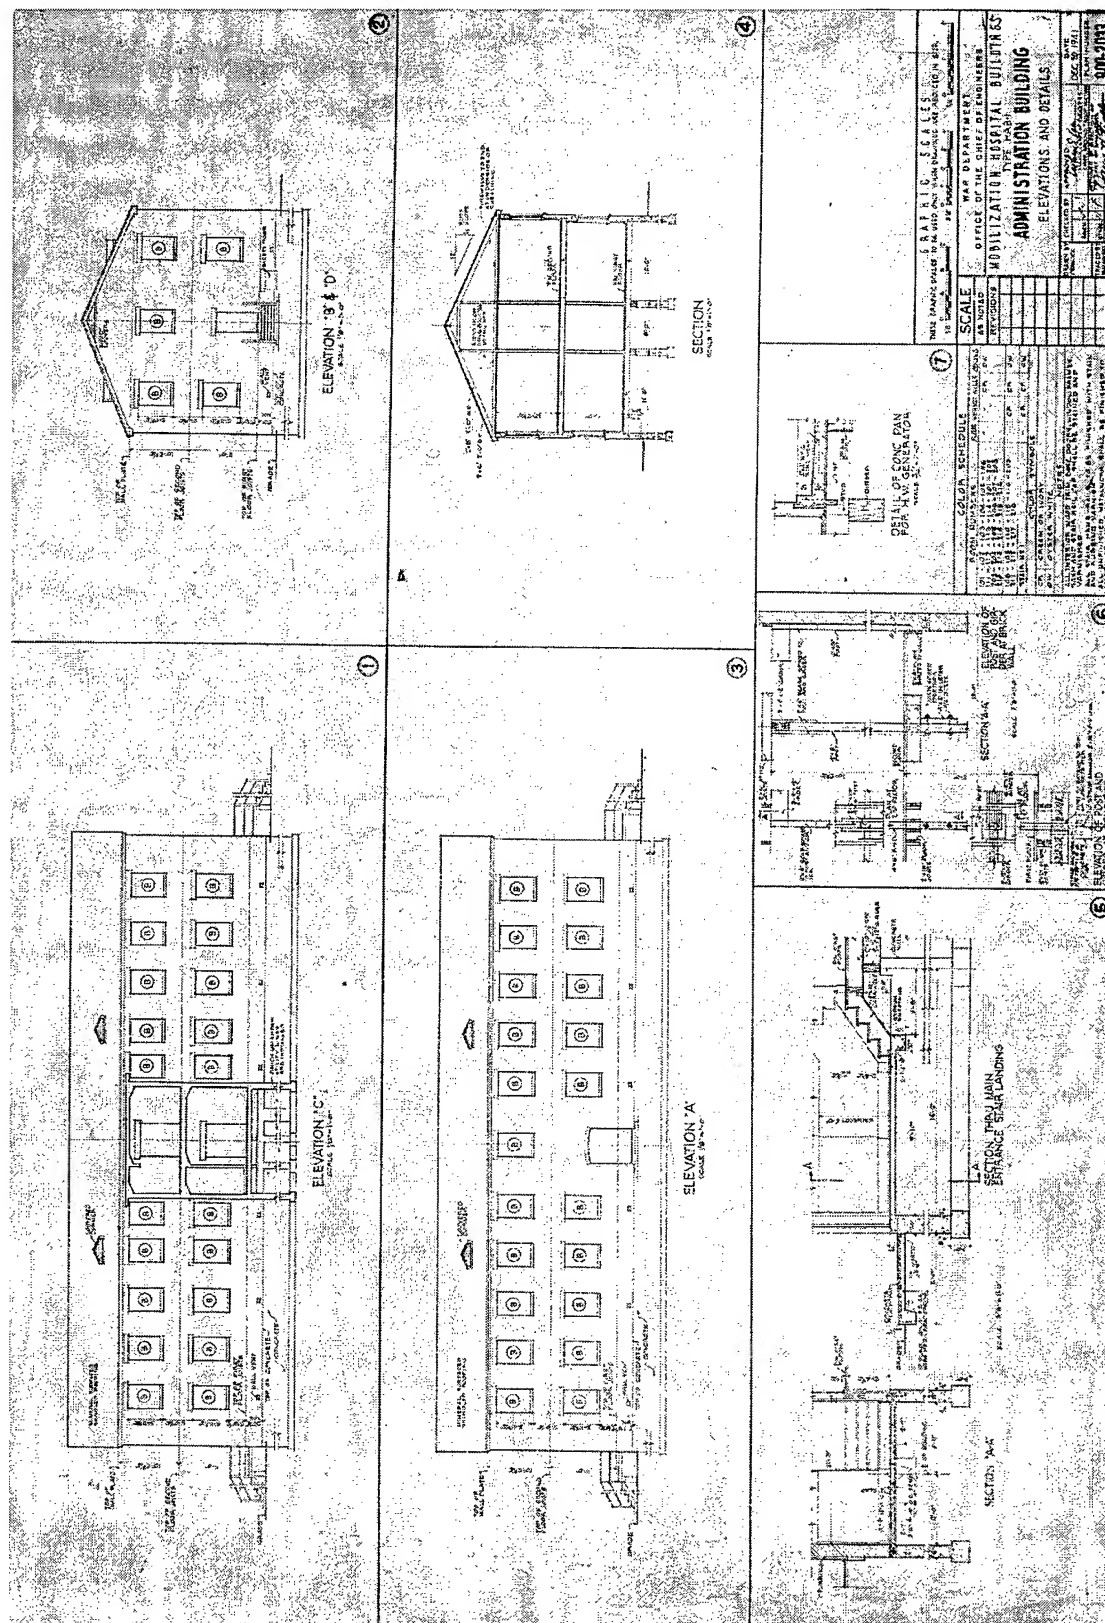
Figure V.6 5EP1778. Elevations and details for Building S6225, Administration Building, 800 Series, Type HAB-1, Plan 800-2033.

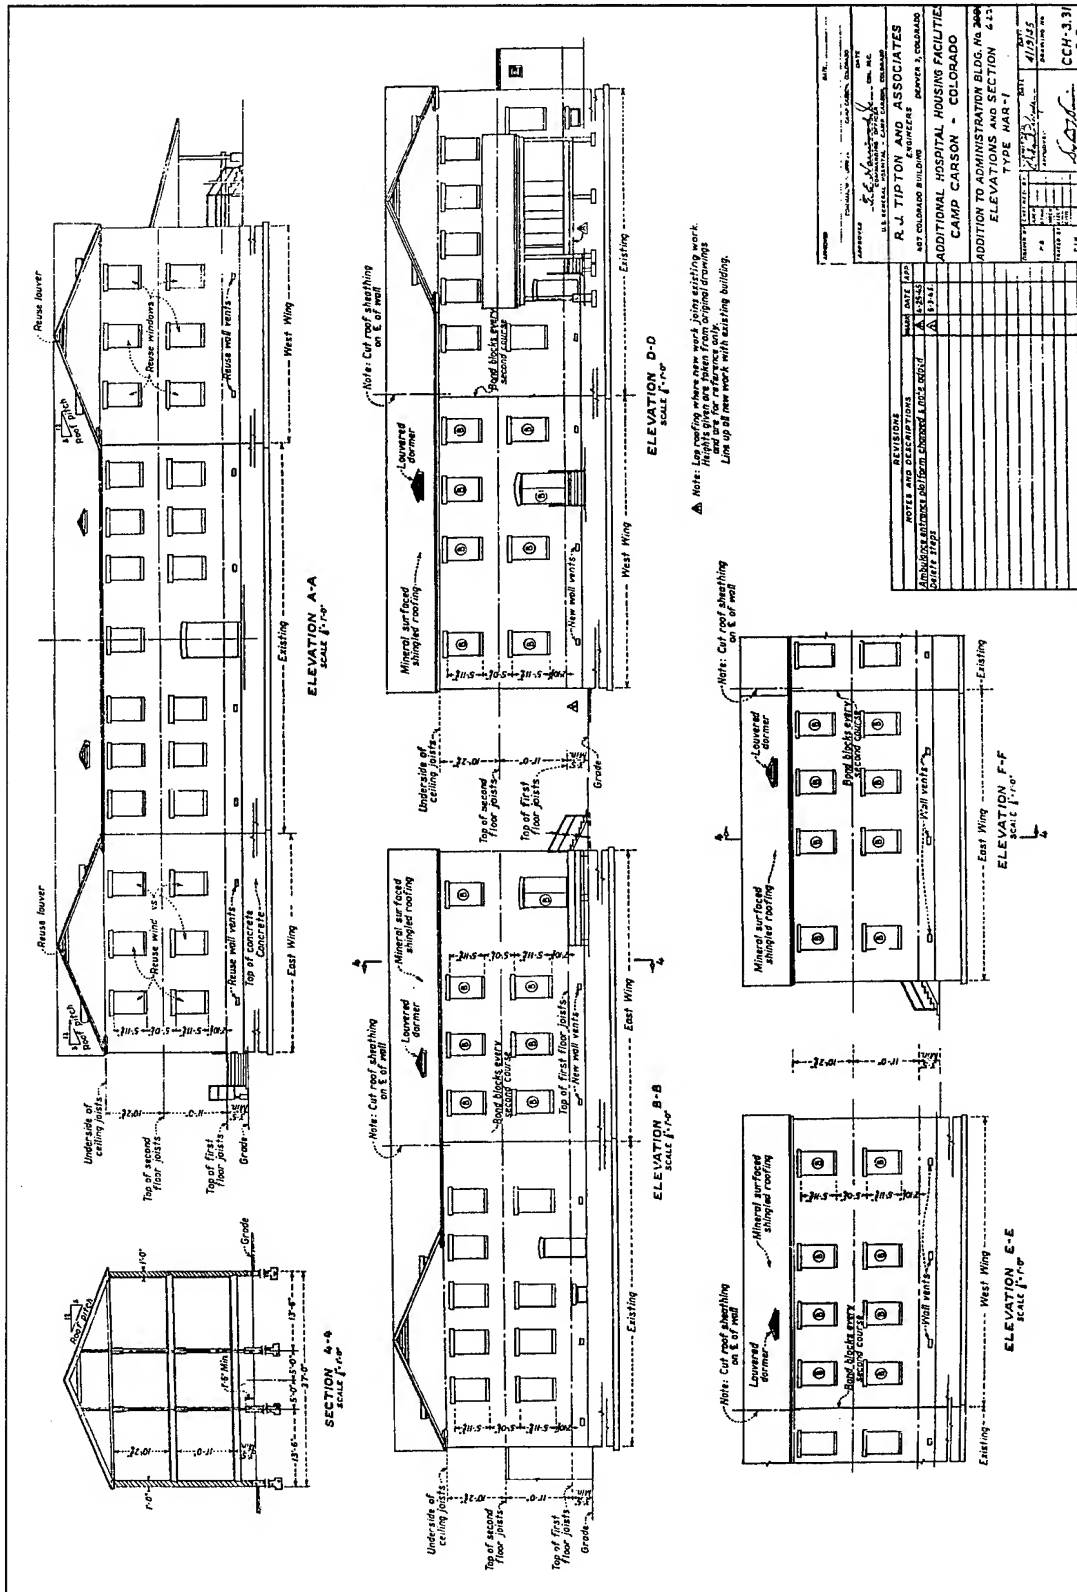
Figure V.21 SEP1778. Elevations and section for Building S6226, Administration and Receiving, CCH Series, Sheet 3.31.

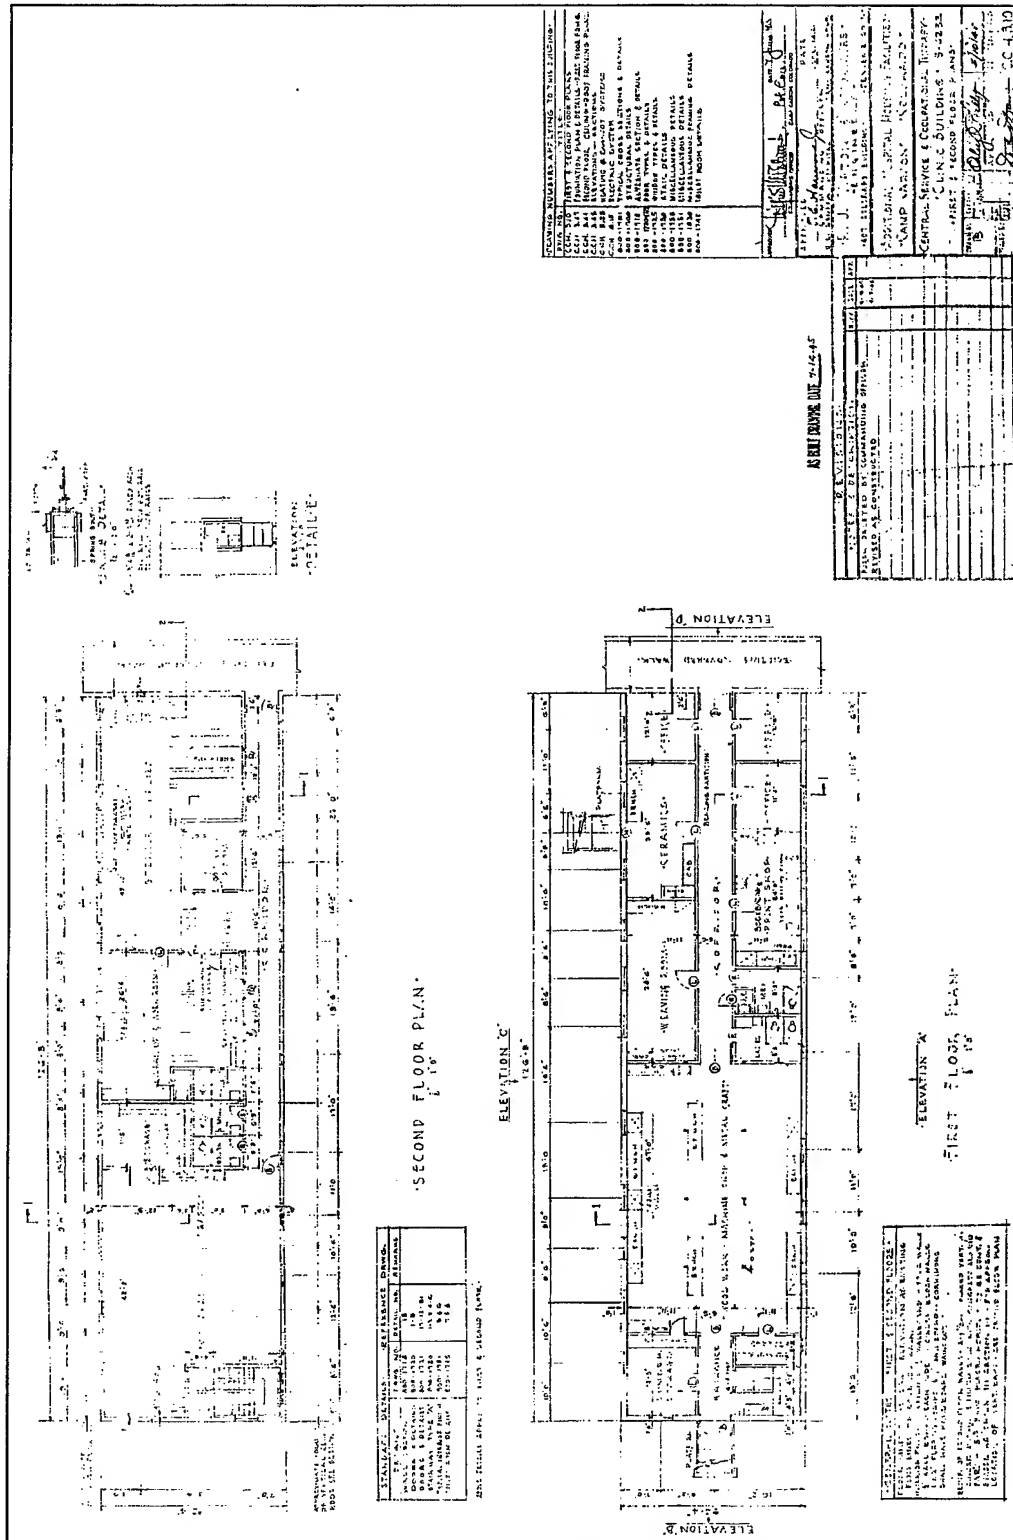
Figure V.31 5EP1778. First- and second-floor plans for Building S6232, Central Service and Occupational Therapy, Clinic Building, CCH Series, Sheet 4.3.10.

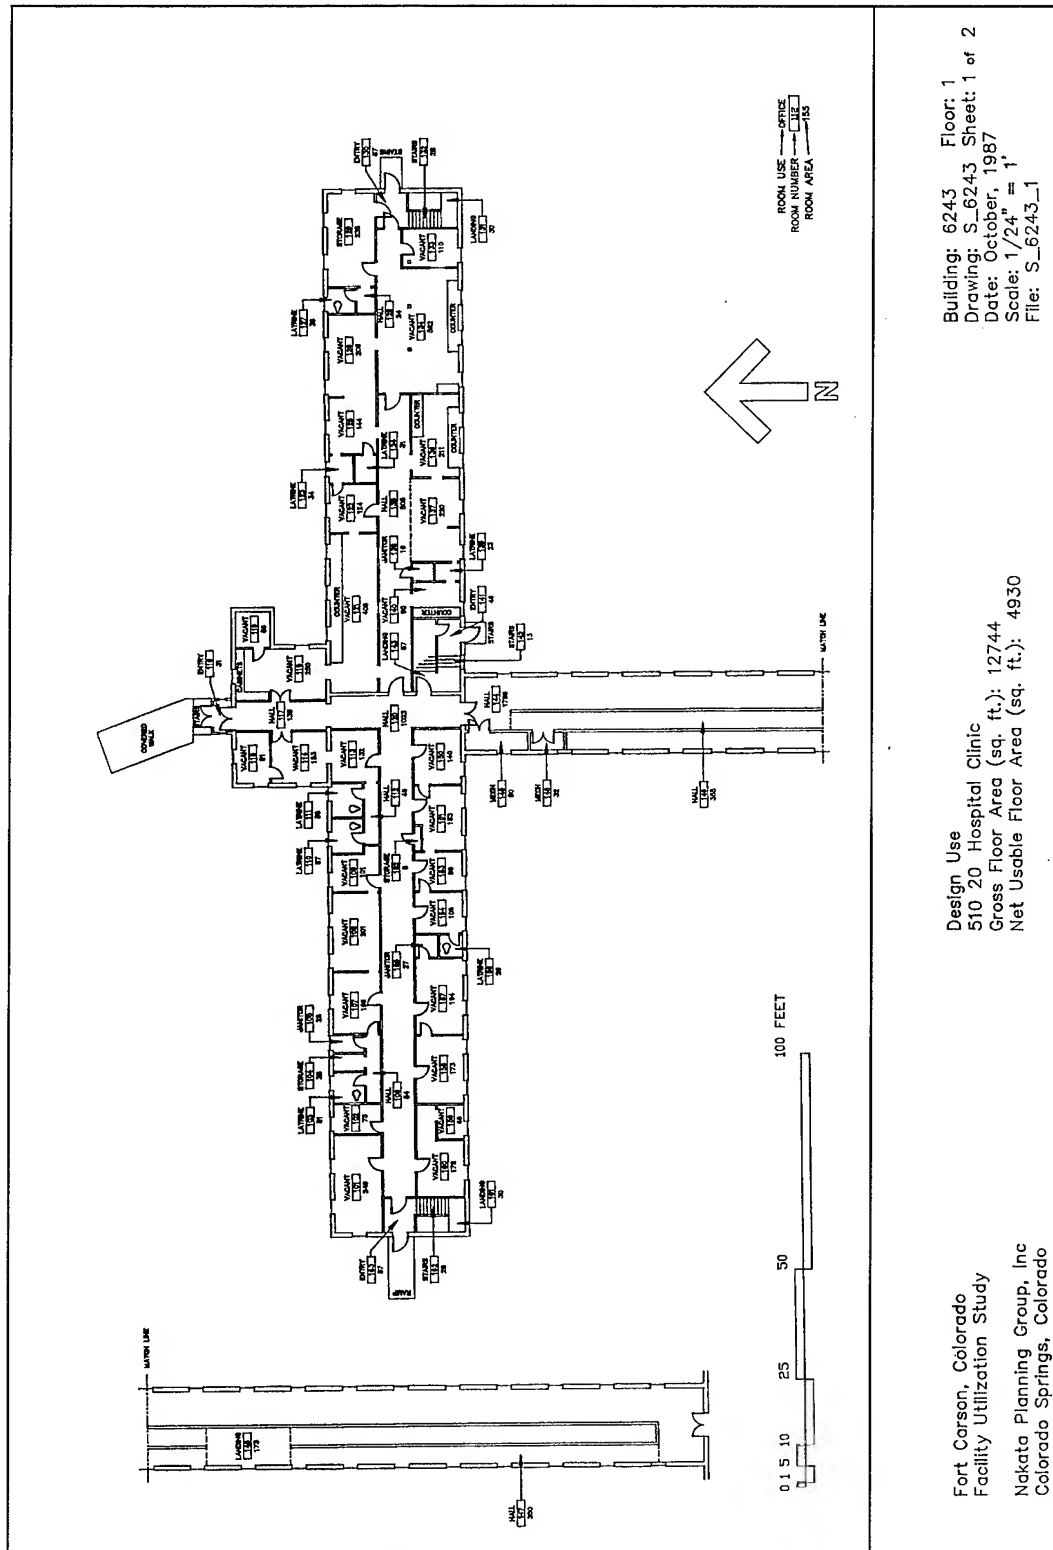
Figure V.36 SEP1778. First-floor plan for Building S6243, Clinic, BUD Series.

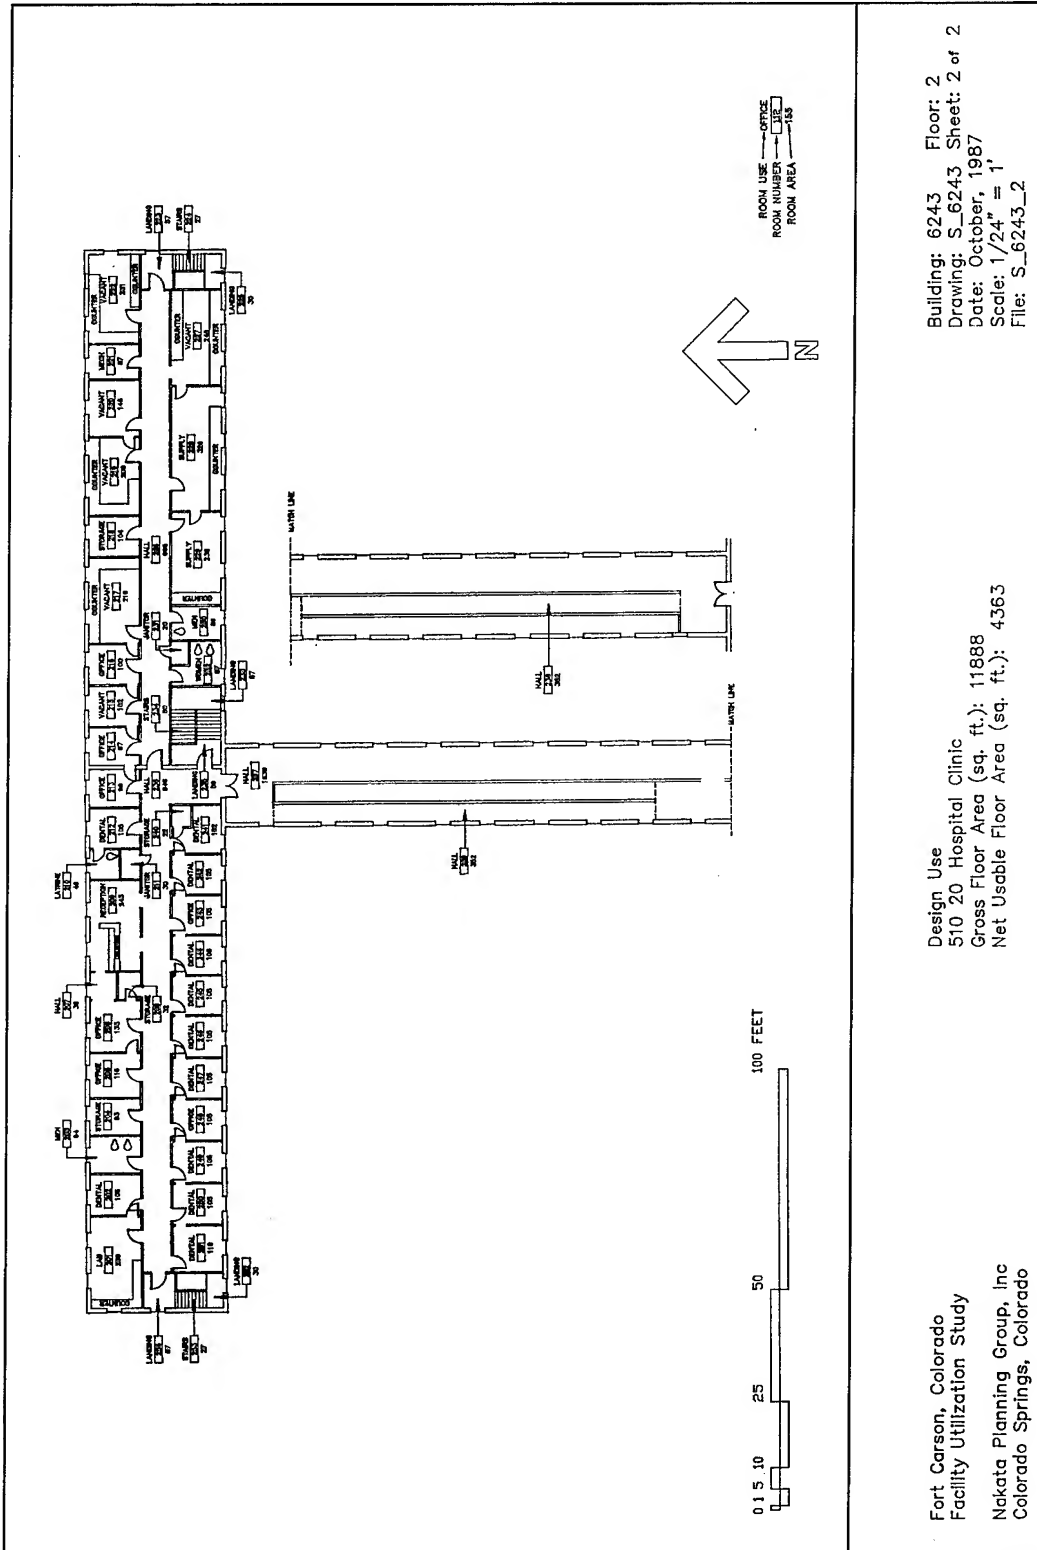
Figure V.37 5EP1778. Second-floor plan for Building S6243, Clinic, BUD Series.

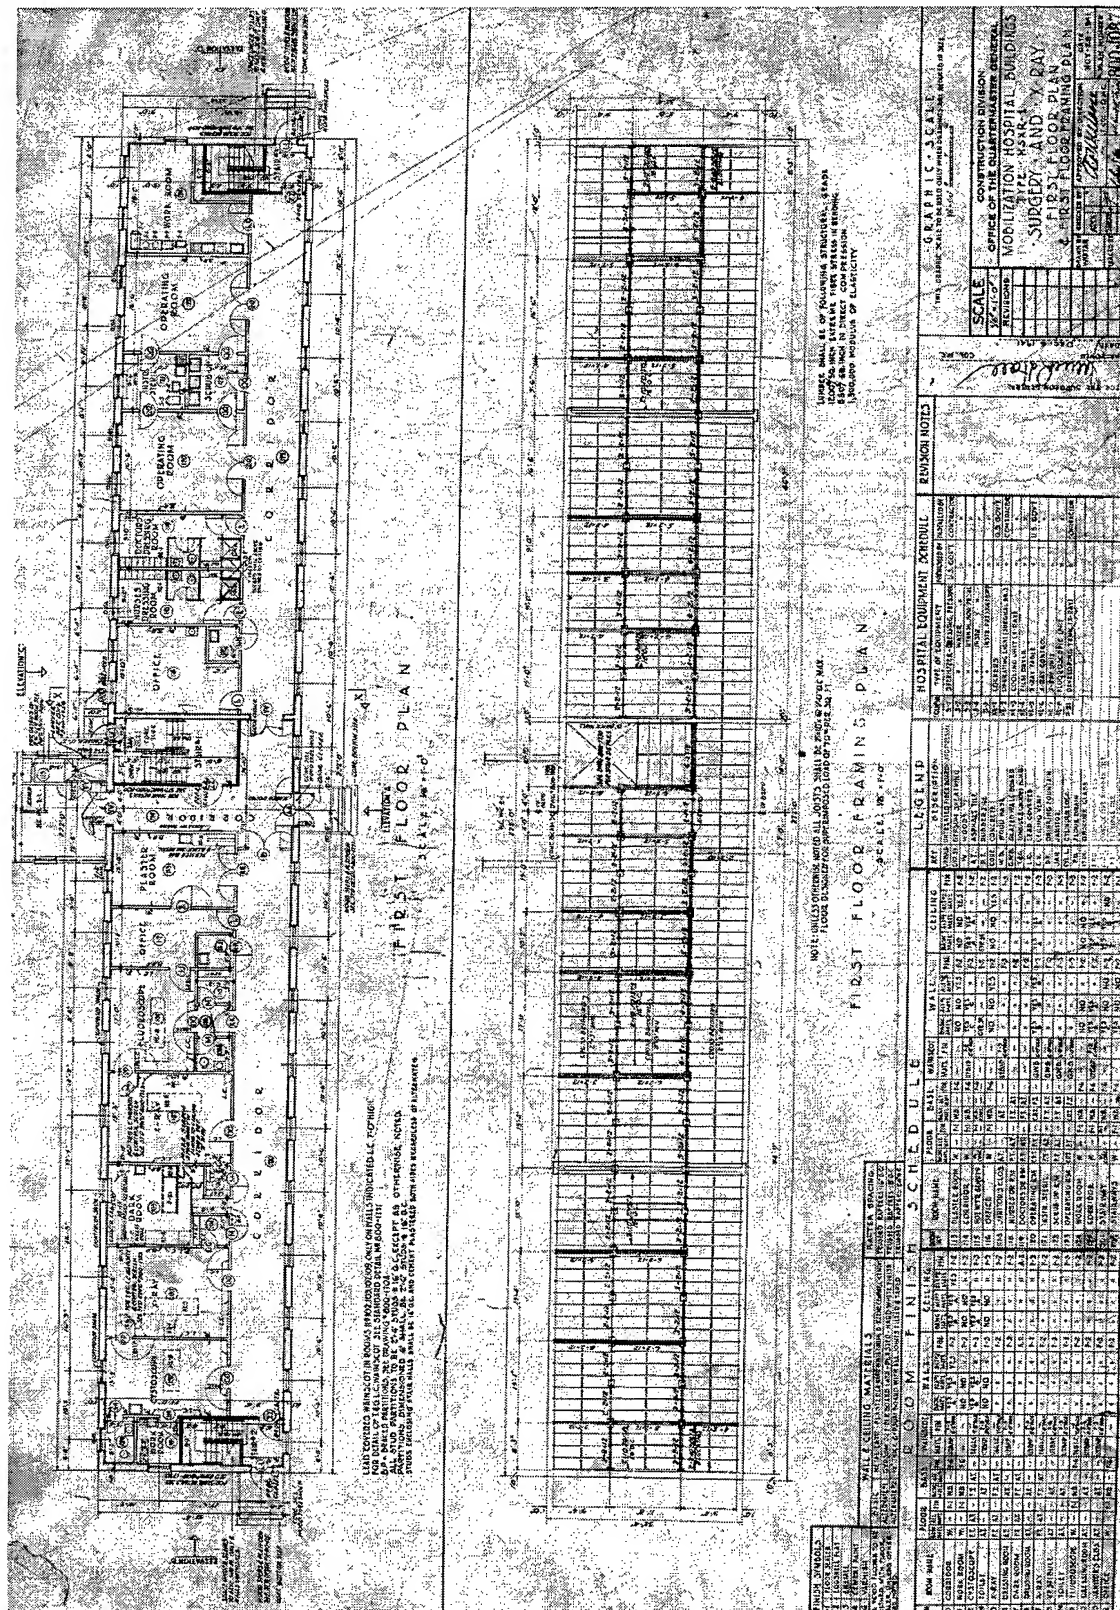
Figure V.54 SEP1778. First-floor plan for Building S6233, Surgery and X-Ray. 800 Series, Type HSXR-1, Plan 800-1987.
